Building Conservation Assessment Report

Hammenpoort “Karnbarn”

MSc 2 AR0015
Building conservation Assessment

Inspection Period
28/02/2018 - 21/03/2018

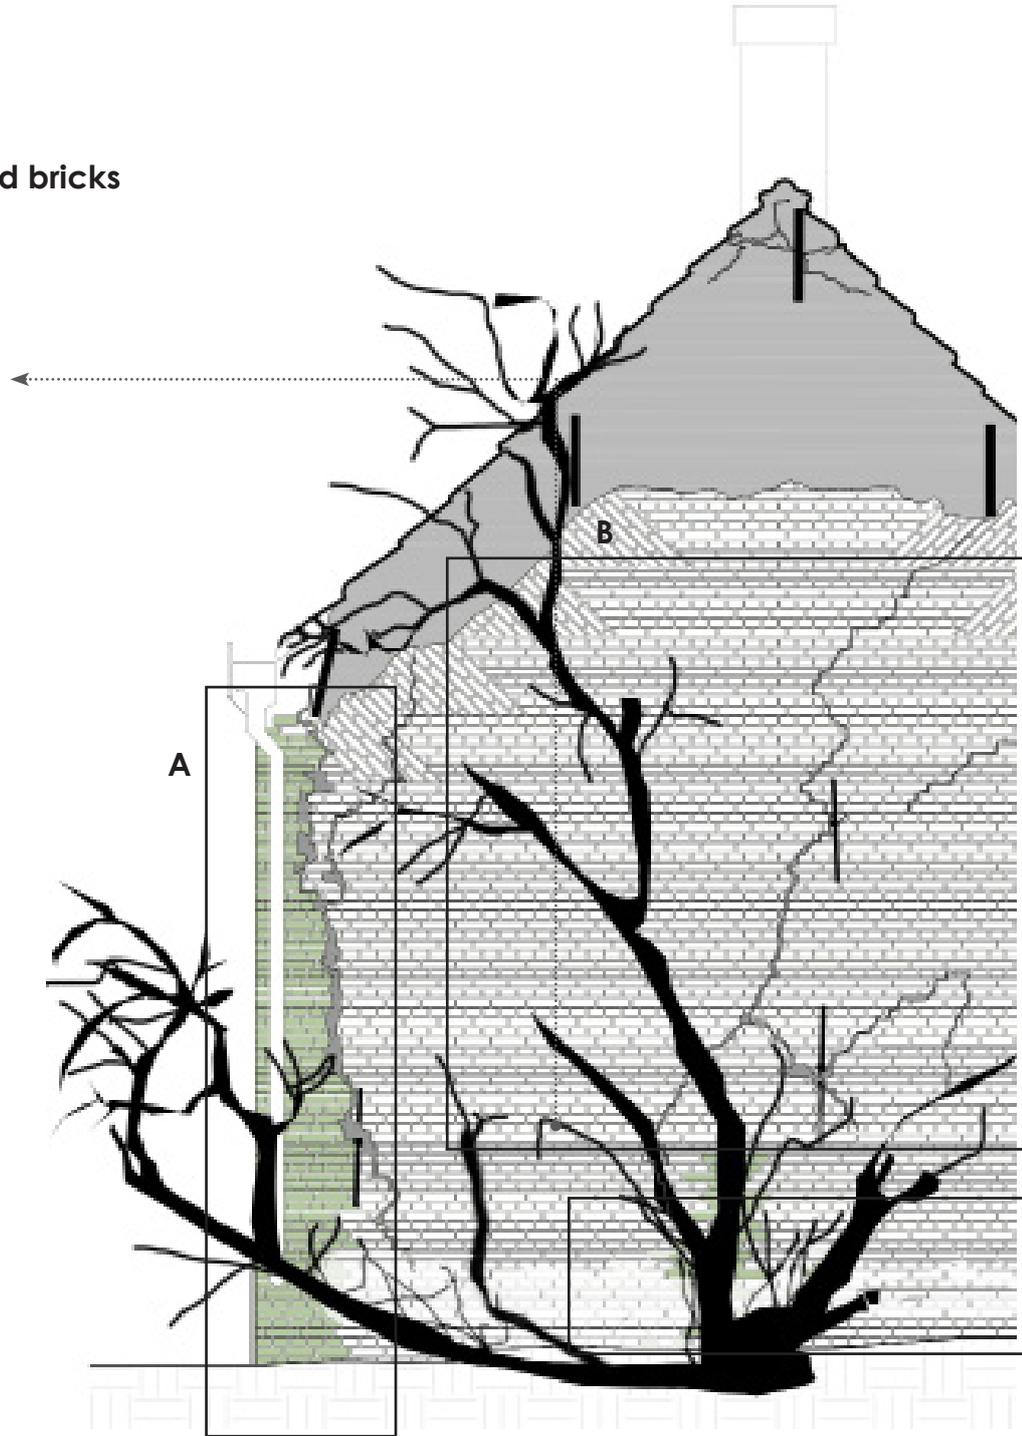
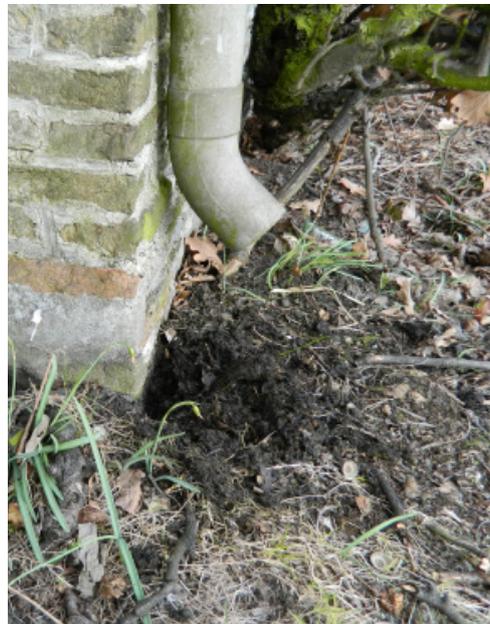
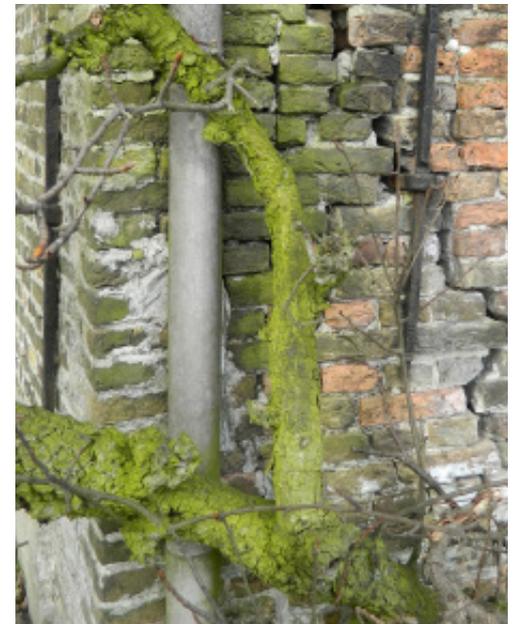
Damage Type A: Biological growth on masonry wall

Brick » Biological growth » Algae may enter into symbiosis with lichens.

The south wall is exposed to large amounts of daylight therefore biological growth is an uncommon phenomenon. However, there are a lot of trees in the surrounding area that provide shading and could contribute to the biological growth. Furthermore, we observed that the biological growth is mostly concentrated on the area close to the gutter and the drainage pipe. As a result, it could be there due bad drainage and leakages that keep the masonry wall moist even with adequate exposure to sunlight.

This type of damage is not structurally harmful. The most important part is to improve the drainage system and avoid leakages that can exacerbate the problem or cause other problems.

Algae can be removed, but its only because of its aesthetic influence to the existing facade. Brushing and washing are the least invasive techniques that can be implemented.

However, since there is no serious reason why it should be removed we decided to avoid cleaning.

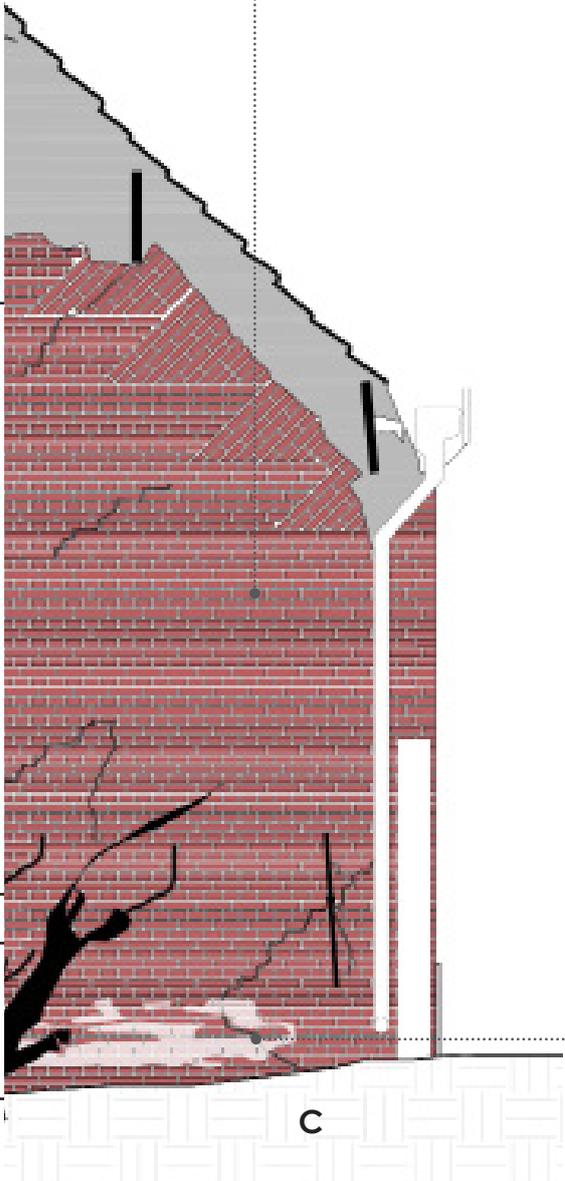
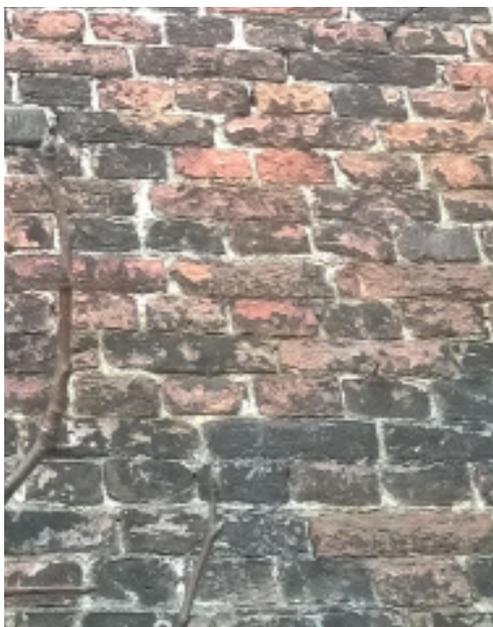
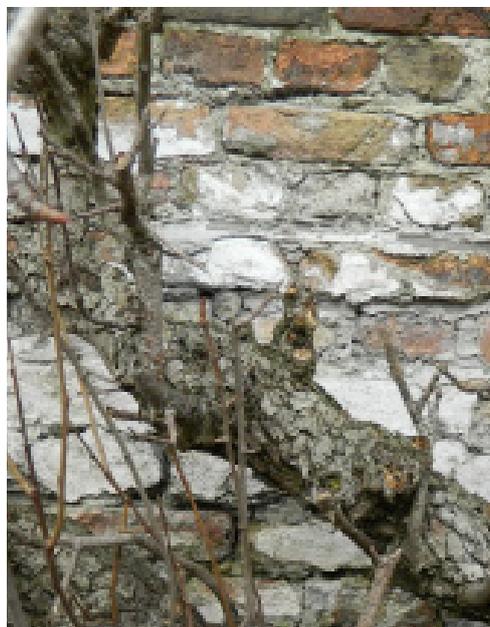
Damage Type C: Surface Change on Hand-moulded bricks

Brick » Surface change » Staining
Remaining material from the missing cement plinth can be found on the bottom of the masonry wall.

From our archival material, such as historic photographs and text we found out the South wall had once a cement plinth just like the other sides of the building. This plinth has fallen off, possibly due to the growth of the tree. Its remains are still present at the river bank -. The hand-moulded bricks still carry a thin layer of the cement plaster in certain areas.

Similarly to the above damage, there are no structural implications. The layer of the cement plaster can be cleaned but this poses a risk of further damaging the bricks. We would suggest either to leave as it is where there remaining plaster is a reminder of the original character of the building or repair it.

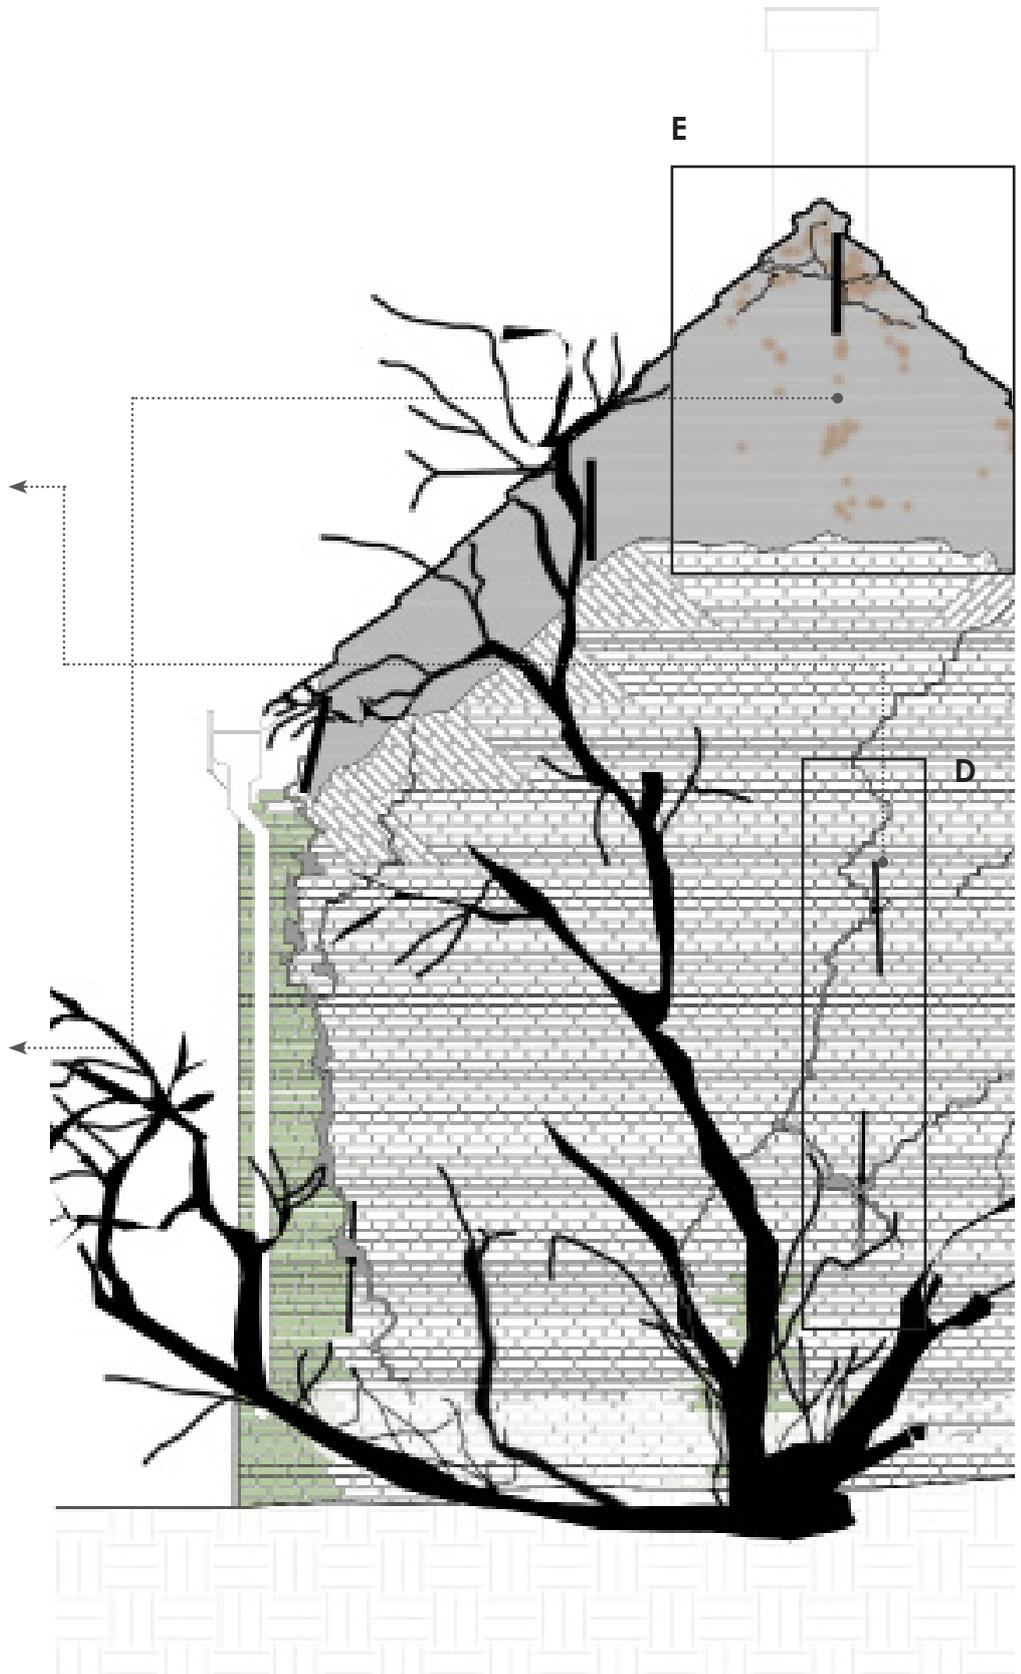
Damage Type E: Plaster » Biological growth » Lichens

Lichens grow under external climatological conditions, in patches, and have a leathery appearance; they are usually yellow, orange, red, brown, grey or black. A closer look will reveal different forms resembling to: crusts, scales and leaves.

This type of damage is not structurally harmful. Brushing and washing are the least invasive techniques that can be implemented. However, since there is no serious reason why it should be removed we decided to avoid cleaning.

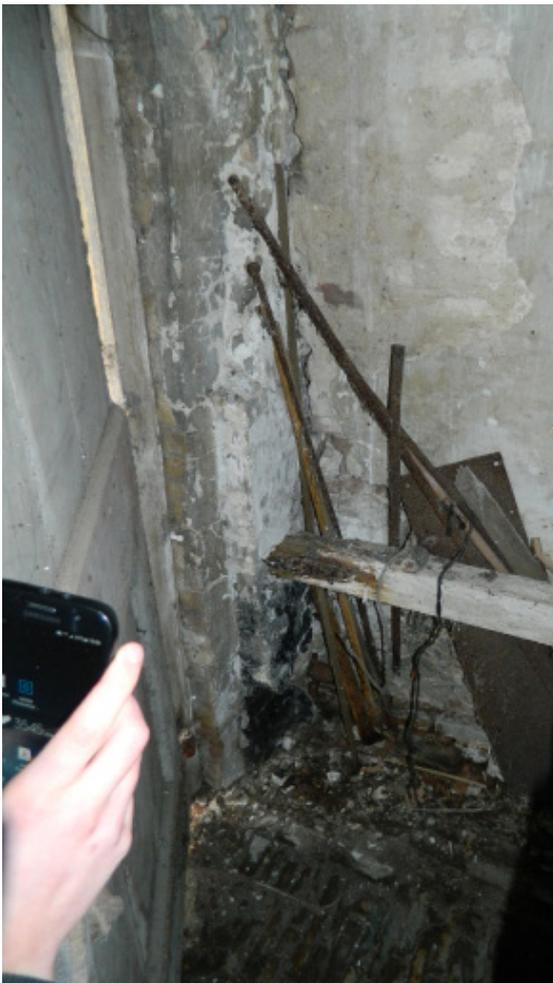
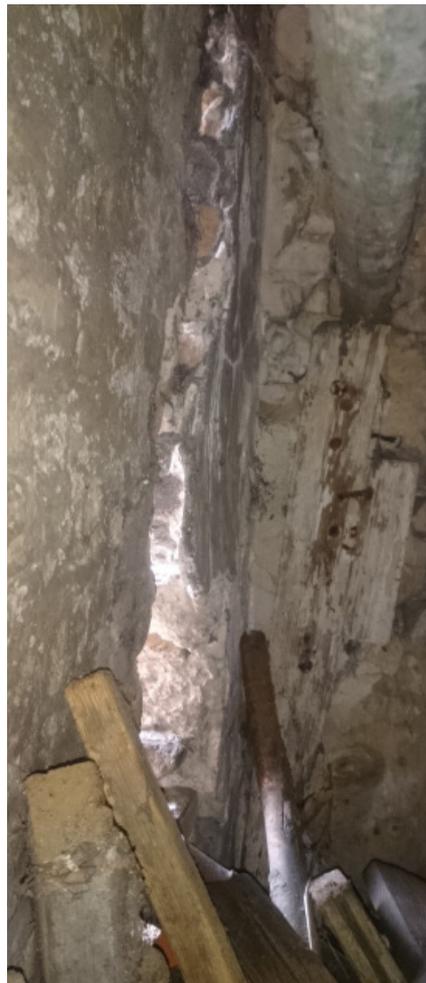
Damage Type G: Plaster » Cracking » Star crack

A star crack has the form of a star, that is to say it has a central point where from cracks similar to rays stretch out in all directions. N.B.: Rusting iron or impact load are possible causes of this type of damage. Layering (more than one layer) of material with an originally not laminated structure.

See further study with external cracks

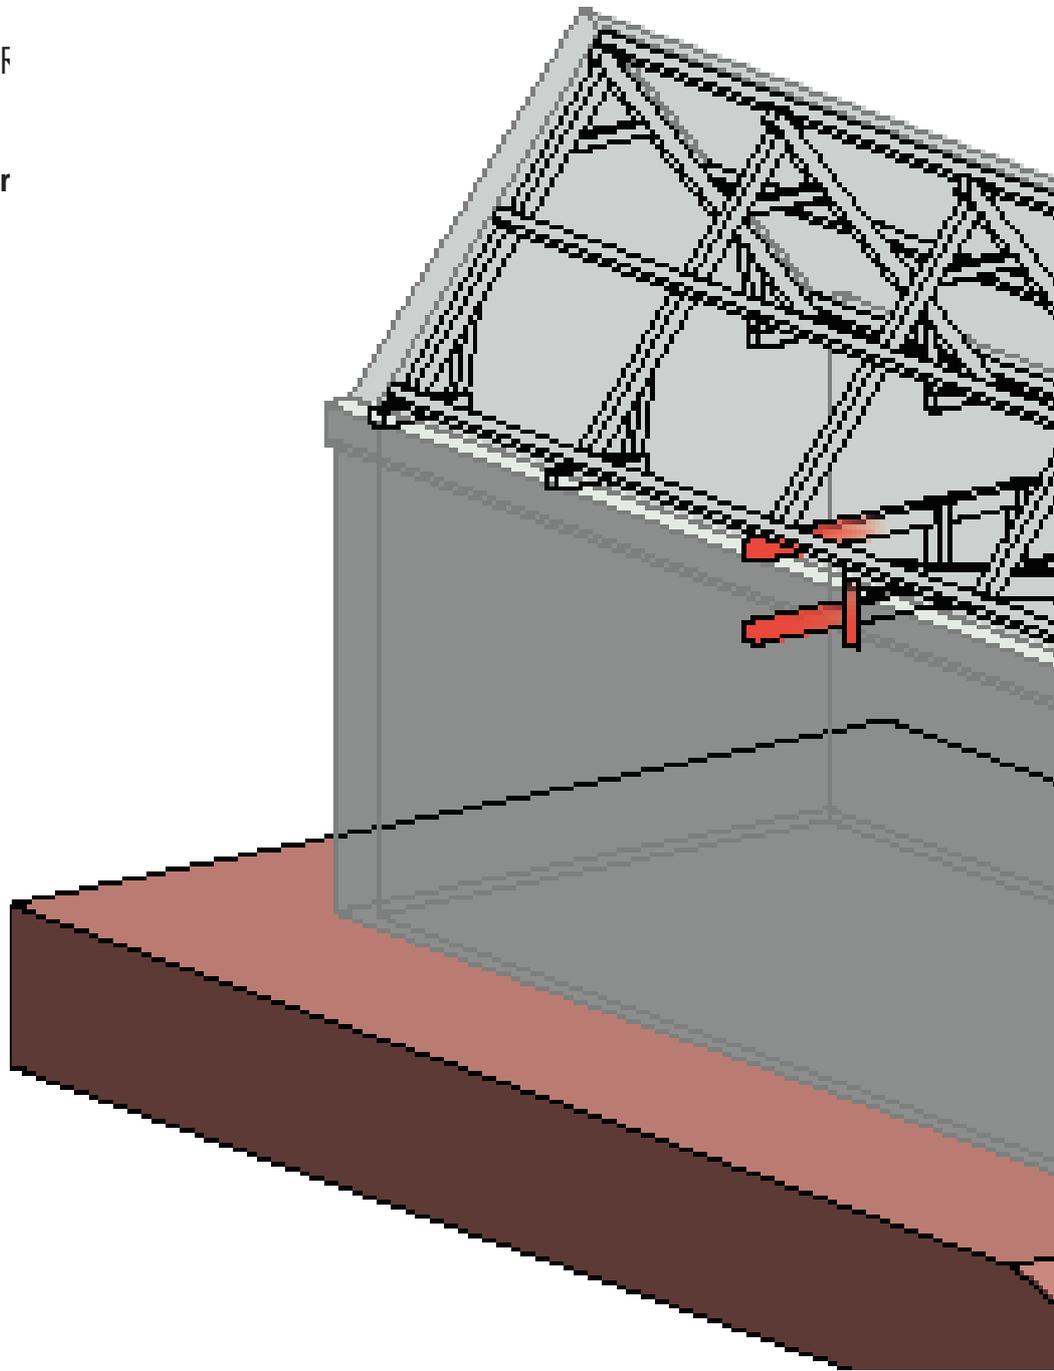
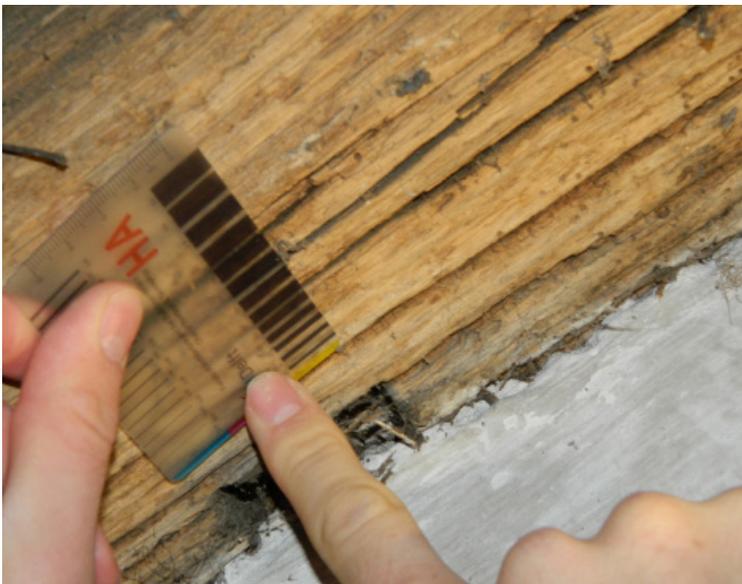
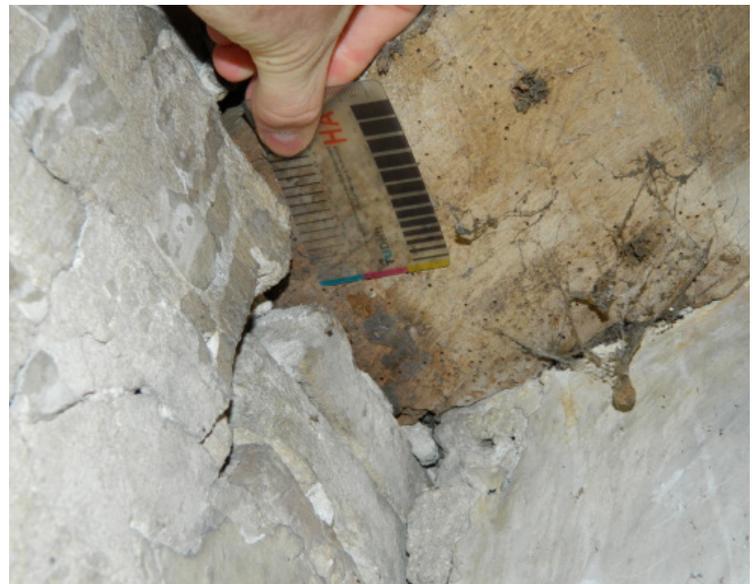
Damage Type: wood rot on the construction of the mill.

No fruit body, no strands, no mycelium. Without fruit body, strands or mycelium in the parts of highest humidity, especially adjacent to outer walls.

Hypothesis: The rot occurs strongest in parts of highest humidity, especially adjacent to the outer walls. The cross cracks are mostly minute or non-existent, which implies that it must be a case of wet rot.

Due to the absence of fruit body, mycelium, strand and a partial silver-grey surface it can be assumed that it is either a soft rot or an unidentified type of brown rot.

In order to stop the rotting the sources of humidity must be located and stopped. Additional dehumidifying may be necessary/helpful.

The timber should be analysed regarding its structural strength and if required be supported. All rotted wood should be removed and ventilation or at least vapour barriers between timber and masonry should be provided.

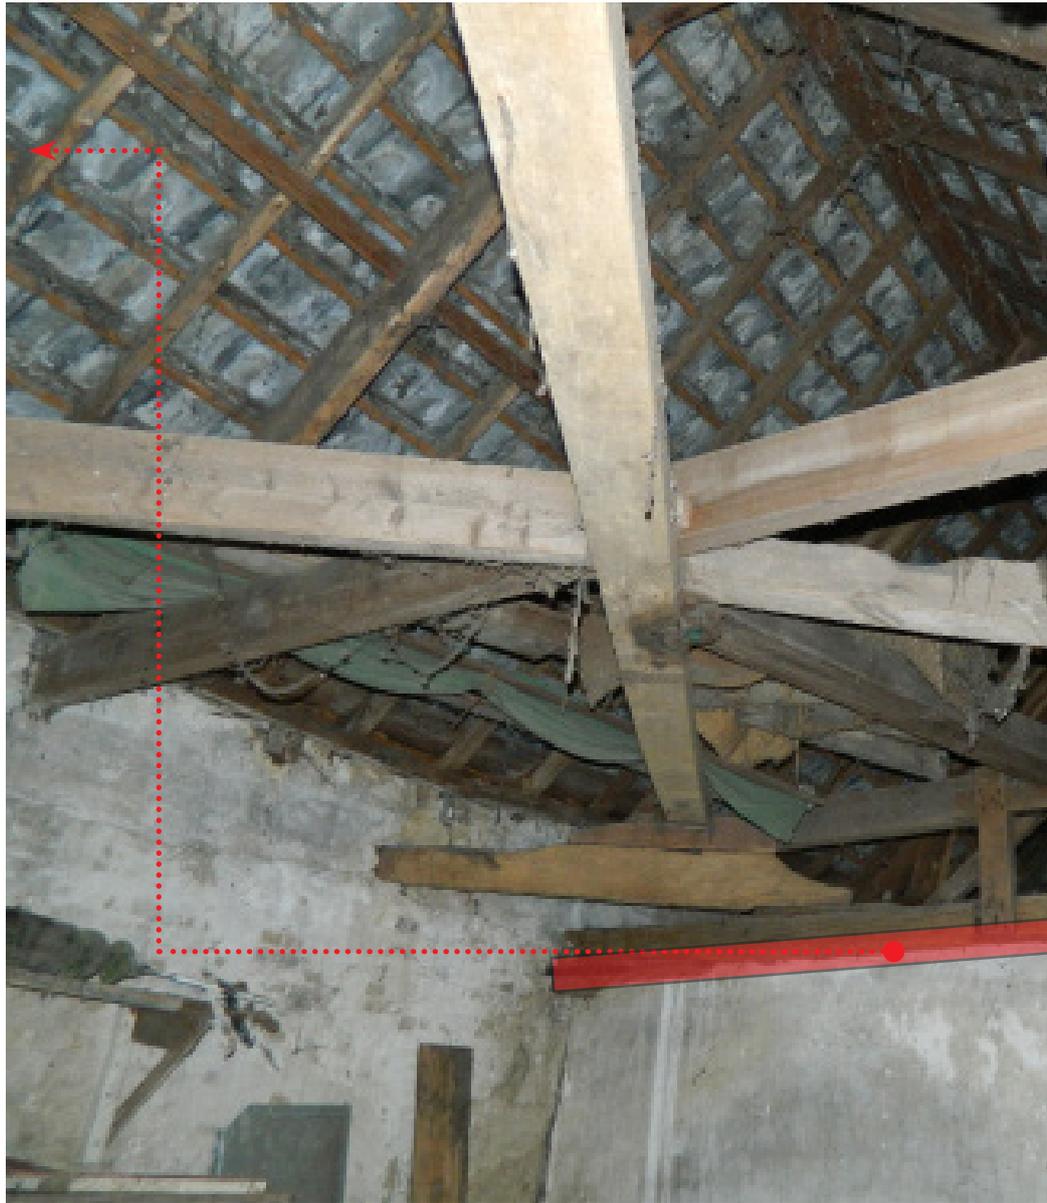
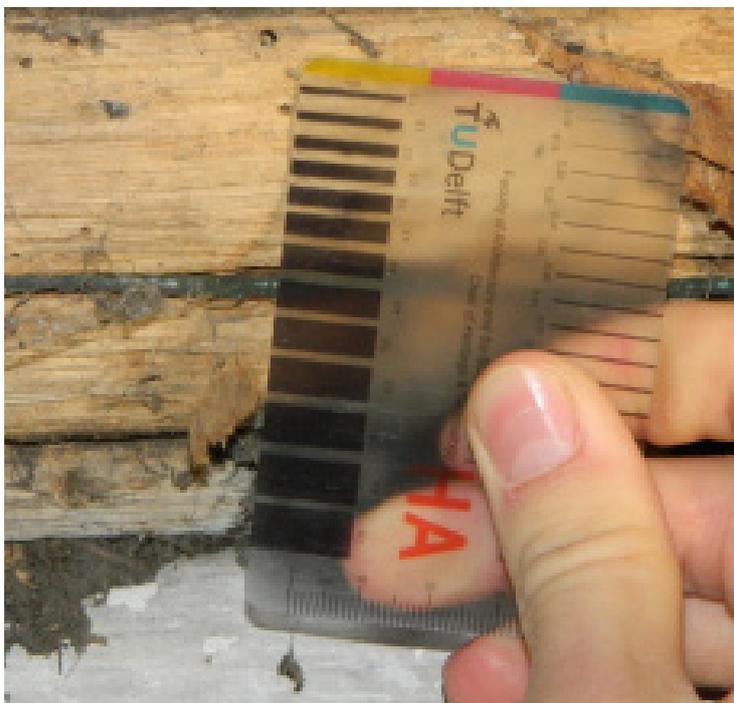
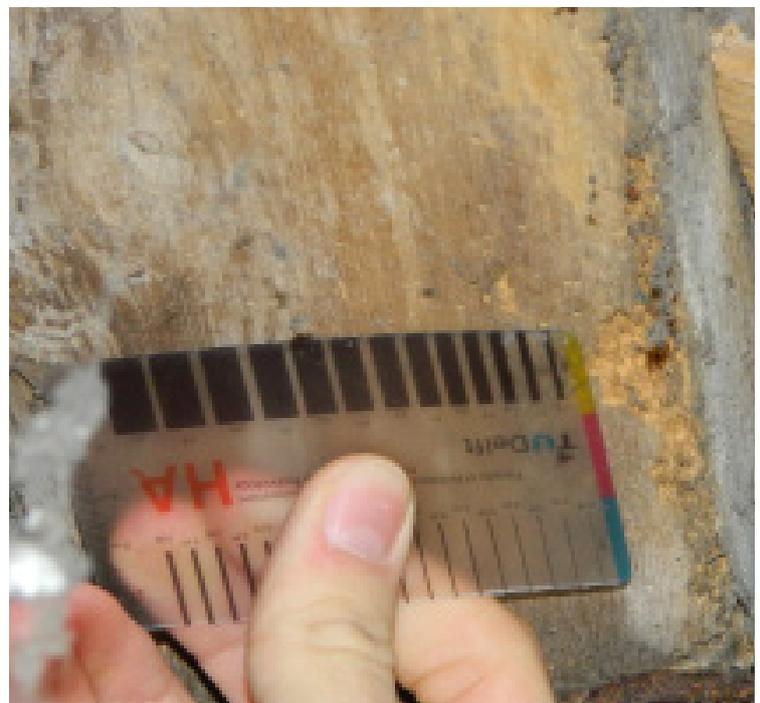
Damage Type A: damage with circular holes of 1-2 mm diameter, no bore dust, no larvae

Hypothesis: As neither bore dust nor larve could be found, an accurate specification is difficult. Due to its popularity in rot affected construction timber, its 1-2 mm big emergence holes and its orientation - random, but mainly in direction of the grain - it can be assumed that the damage is cause by anobium punctatum, the commo furniture beetle.

As the beetles are not there anymore, no remedial treatment has to be executed. As the damage is only found in timber that has no load bearing function anymore, the affected timber can even remain if it is capable of sustain its own weight.

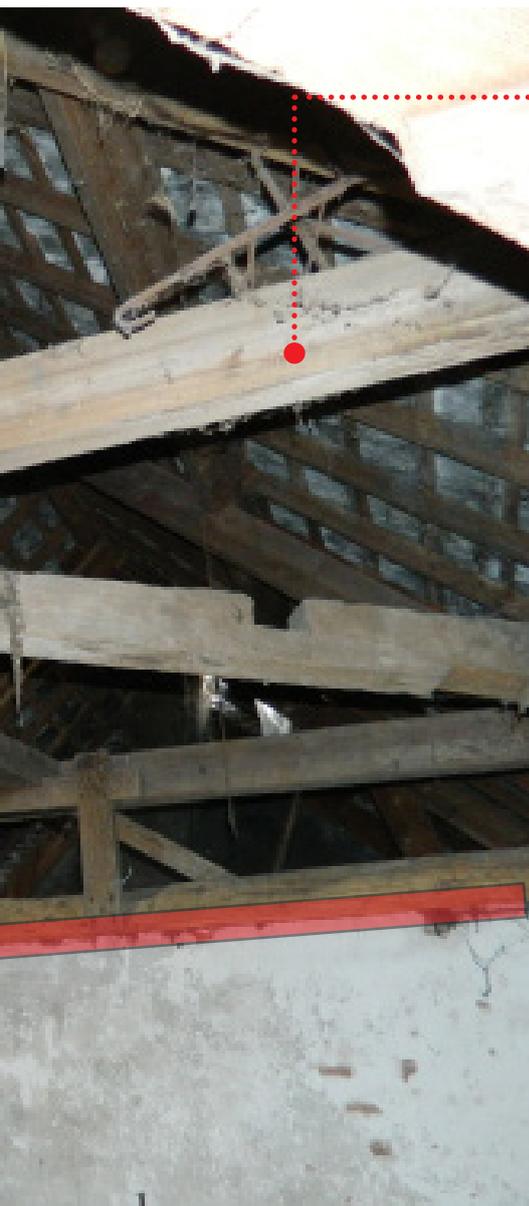
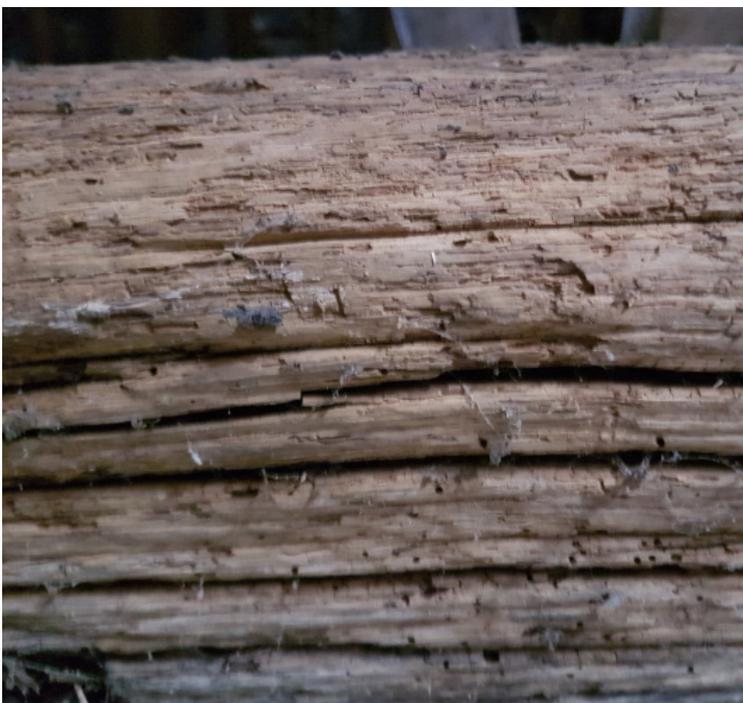
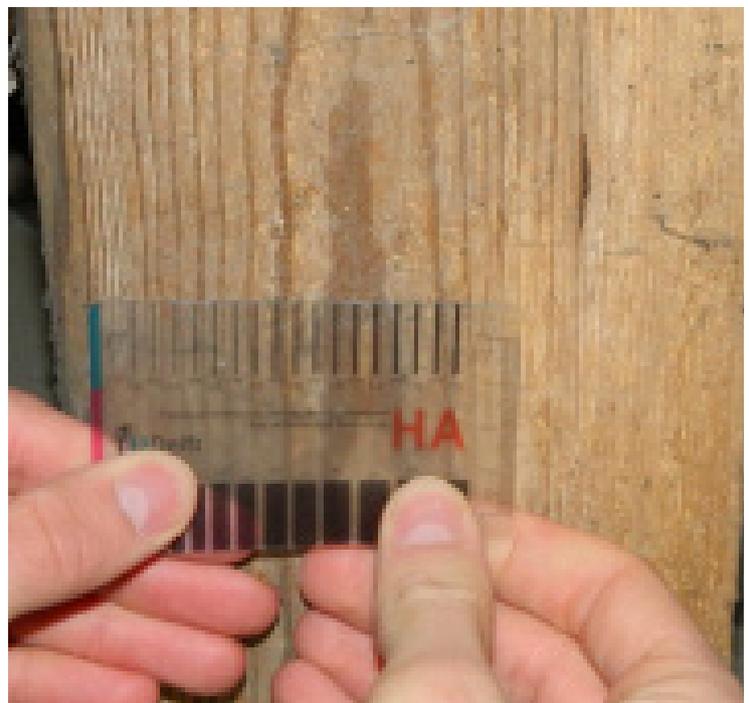
Damage Type B: damage with circular holes of up to 1 mm, no bore dust, no larvae

Hypothesis: As neither bore dust nor larvae could be found, an accurate specification is difficult. Due to the small size of the bore holes, the tunnels breaking through the wood surface and their occurrence in damp timber directly connected to walls we can assume that the damage is caused by wood-boring weevils (*euophyrum confine*).

Wood-boring weevils can be removed by removing the damp conditions, but as these smaller holes and tunnels seem equally deserted, no remedial action must be taken. It should be tested though, if the timber is still sufficiently load-bearing.

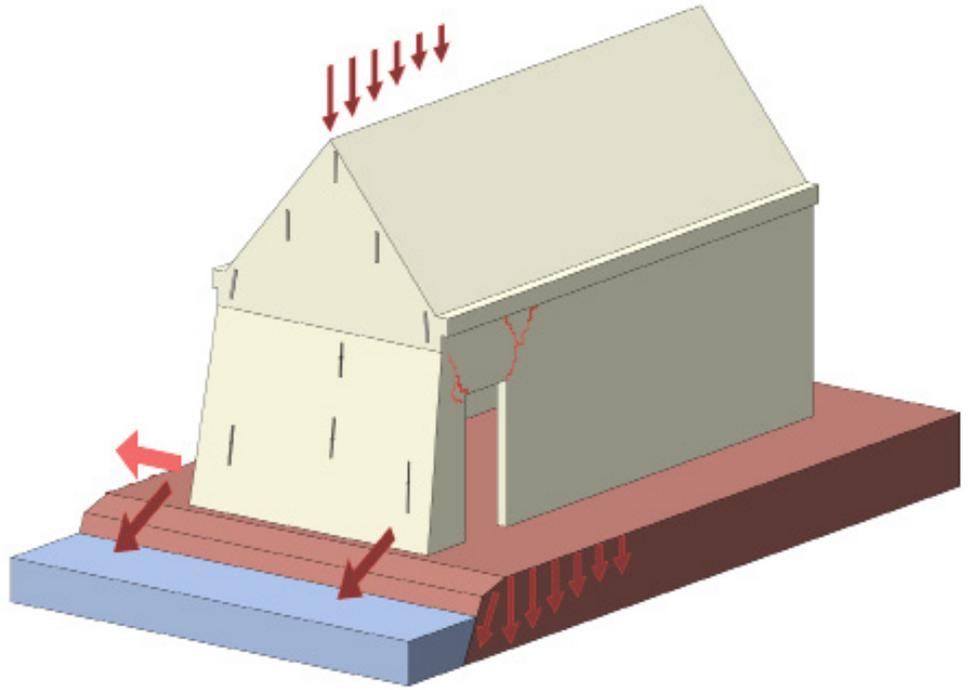
Structural damage > Cracking
> Cracking in column or wall
> Combination of cracks in different directions

Hypothesis: Due to the movement of the southern wall to the direction of canal the cracks form above the door on both sides. The crack on the side closer to canal is widening downwards, because the base of the wall is moving away from the door. Crack on the other side of the door is opening upwards, which suggests that the brickwork above the opening had no sufficient support.

As stated in the first point, most of the damaging processes are related to settlement. First the ground must be stabilized, before further repairs would make any sense - if the settlement proceeds, the cracks will most probably re-open even if they would be sealed in the early stage of intervention.

For safety reasons temporary support for the door can be provided to keep the damaged opening from collapsing.

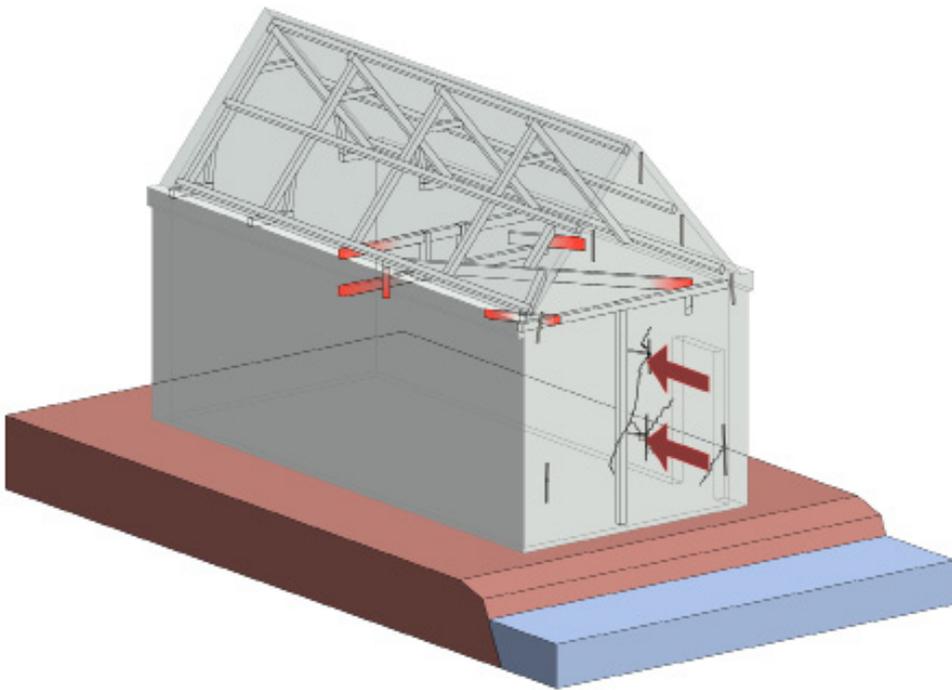
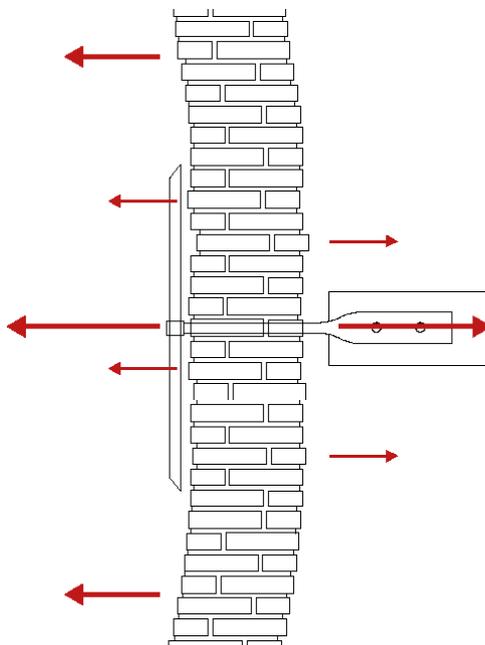
brick > cracking > star crack

The structure of the mill inside the barn is connected to the wall with iron anchors. These anchors, attached to the internal structure counter-act the movement of the wall to the front (caused both by settlement and deformation due to overload). Result of this reaction focused in the points of anchors is the concentrated force causing the star shaped cracks around the anchors.

Since the anchors connect the structure of the mill to the wall it is possible that dynamic forces damaged the wall prior to formation of cracks- the wall was already weakened in the points of anchors. Mill is not active for a long time though, therefore this thread is not active anymore.

Cracks can be sealed, but again as in the previous damage mechanism, it is a priority to remedy the settlement. Without stopping the movement of the wall, the repair of the cracks will probably not be effective, they will sooner or later re-open.

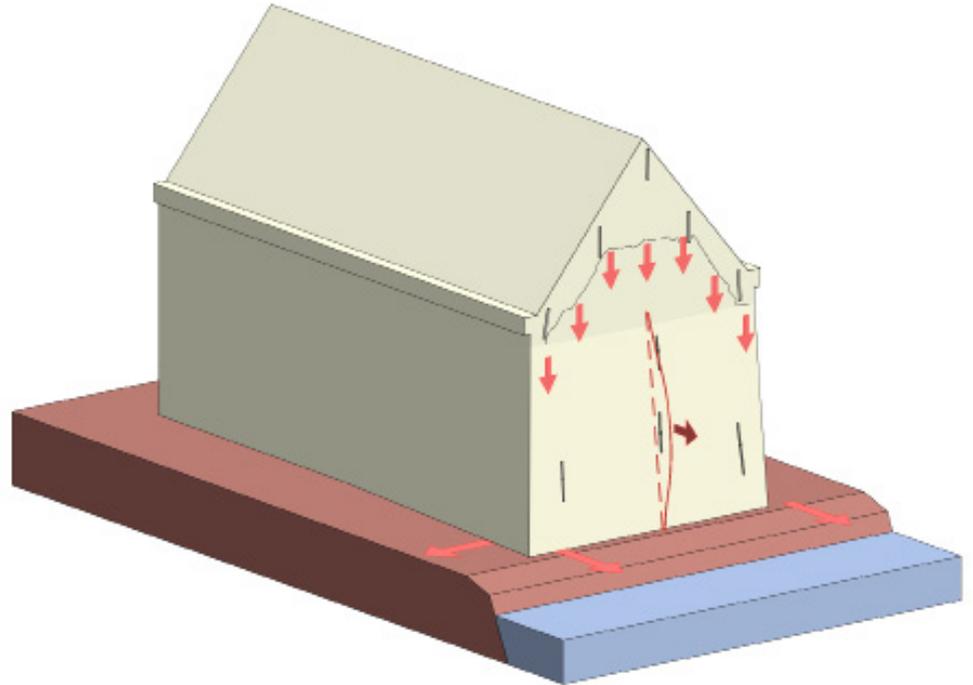
Diagnosis: structural damage
>> deformation >> Deformation pattern 55

Hypothesis: During the recent reconstruction of the roof additional brick layers have been added to the wall and the reed roof has been replaced by roof tiles. By that the load resting on the existing walls increased. This development results in deformation pattern 55, which is facilitated by the settlement displacing the wall from its perpendicular orientation and making it more vulnerable.

A possible intervention could be the integration of a stressed steel rod in the bedding mortar of the existing wall that inhibits further bulging.

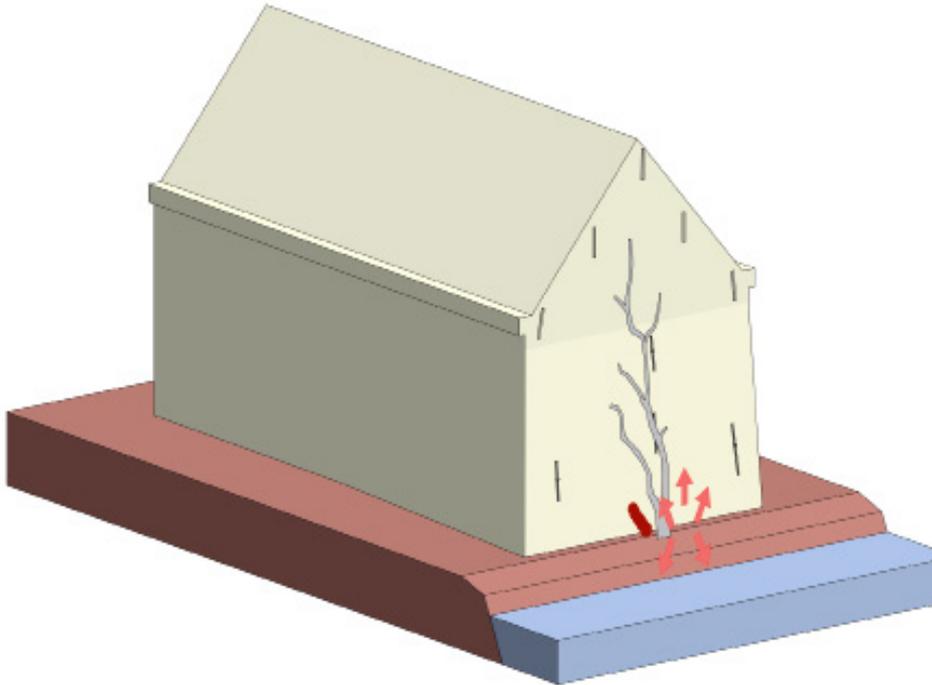
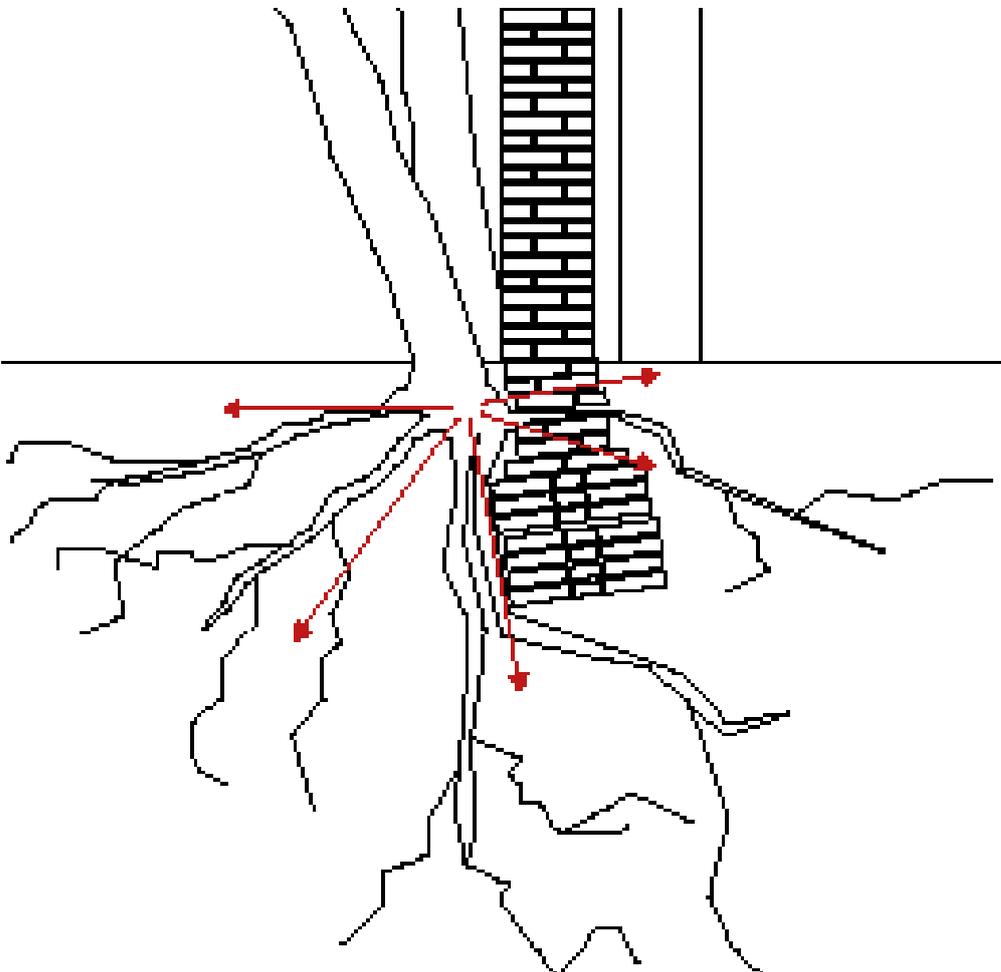
Hypothesis: A tree - adjacent to the wall - is growing from the centre the South façade. Due to its expanding roots eccentric forces push soil and masonry away and parts of the roots appear to even grow through cracks in the masonry. Big parts of the foundation and parts of the wall are displaced. Notwithstanding a supportive structural function can be accredited to the tree as it is holding back the bulging and settling of the wall.

As long as the future use of the barn remains unclear, an intervention proposal cannot be given. Clearly the tree and the wall are strongly connected and only a proper use can justify the removal of the tree (poisoning, reinforcement foundation) whereas leaving the tree be (even though the changes between 2012 and 2018 are minute and the tree seems to grow very slow) will sooner or later result in further displacement of parts of the wall and foundation.
