Building Conservation Assessment Report

Hammenpoort “Karnbarn”

MSc 2 AR0015
Building conservation Assessment

Inspection Period
28/02/2018 - 21/03/2018

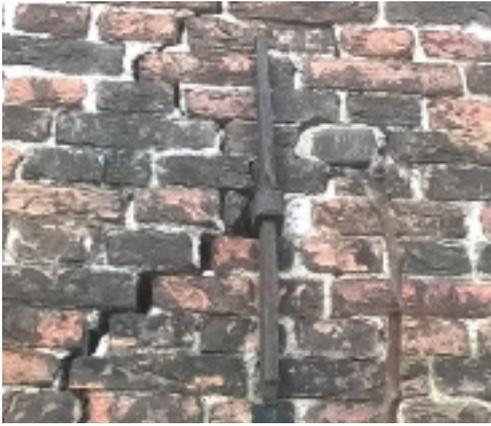
2. Wrought Iron Anchors

Damage Type D: Rust Formation on Wrought Iron Anchor

The iron anchors can be de-rusted and re-treated so as to maintain their structural role in the facade. Anchors that have rusted more than what is possible to be repaired should be replaced.

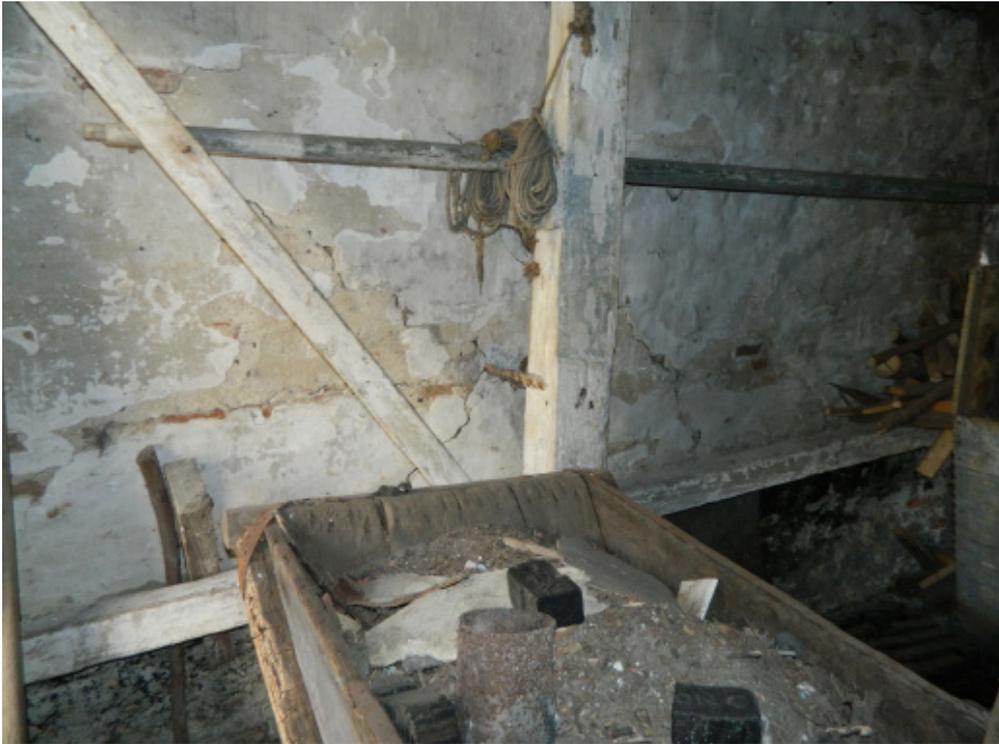
7. Interior Plaster Layer

Damage Type G: Plaster » Cracking » Star crack

A star crack has the form of a star, that is to say it has a central point where from cracks similar to rays stretch out in all directions. N.B.: Rusting iron or impact load are possible causes of this type of damage. Layering (more than one layer) of material with an originally not laminated structure.

Damage Type F: Plaster » Disintegration » Layering » Exfoliation

Repair of plaster layer.

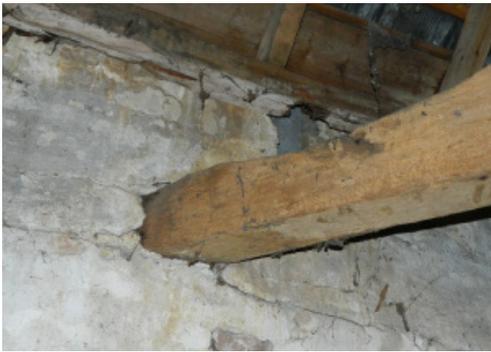
The reconstruction of the barn roof has been the most recent refurbishment. It shows only minor defects like leakage due to broken or disintegrated roof tiles and - as a consequence of wood rot - a weakened eaves purlin and a deformation due to a no more supported truss.

Main attention shall be given to the structure of the now removed mill - the oldest remaining timber-structure in the barn. As the entire building is poorly isolated and various beams permeate the masonry of the outer wall (marked red in scheme), humidity becomes a severe issue for the antique timber.

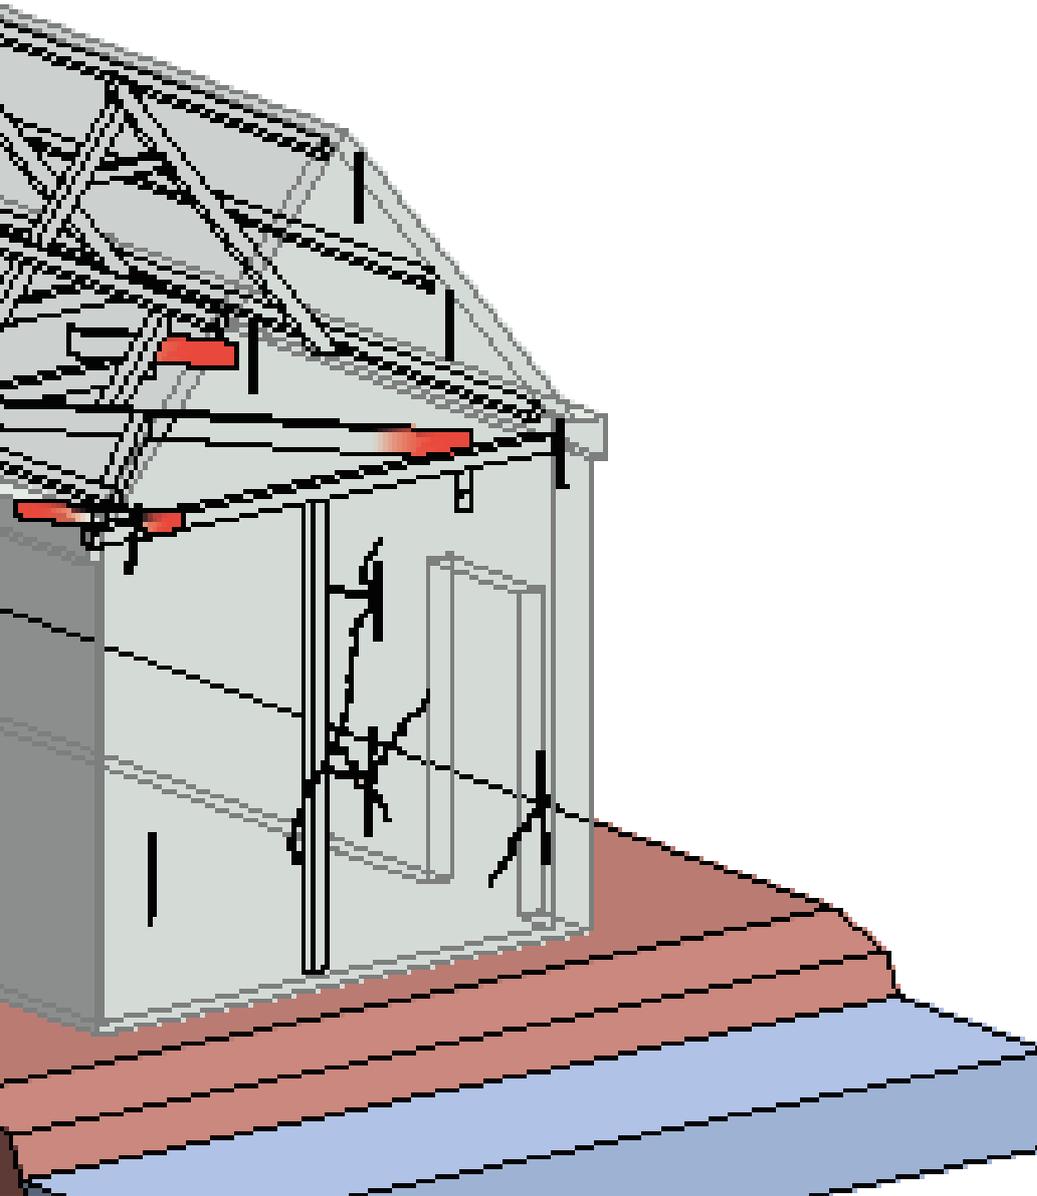
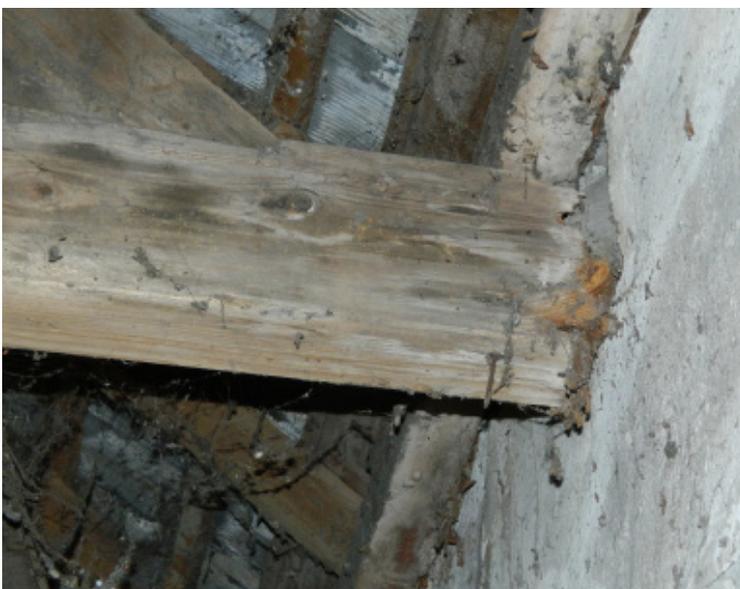
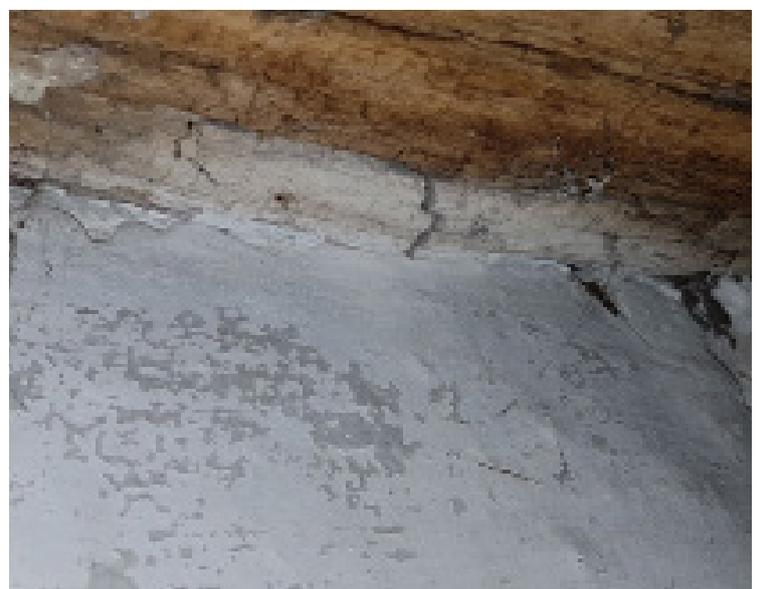
Damage Type: wood rot on the construction of the mill.

No fruit body, no strands, no mycelium. Without fruit body, strands or mycelium in the parts of highest humidity, especially adjacent to outer walls.

Hypothesis: The rot occurs strongest in parts of highest humidity, especially adjacent to the outer walls. The cross cracks are mostly minute or non-existent, which implies that it must be a case of wet rot.

Due to the absence of fruit body, mycelium, strand and a partial silver-grey surface it can be assumed that it is either a soft rot or an unidentified type of brown rot.

In order to stop the rotting the sources of humidity must be located and stopped. Additional dehumidifying may be necessary/helpful.

The timber should be analysed regarding its structural strength and if required be supported. All rotted wood should be removed and ventilation or at least vapour barriers between timber and masonry should be provided.

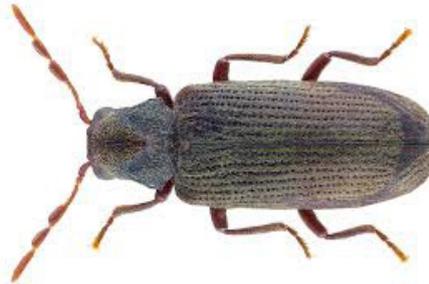
anobium punctatum

Damage Type B: damage with circular holes of up to 1 mm, no bore dust, no larvae

Hypothesis: As neither bore dust nor larvae could be found, an accurate specification is difficult. Due to the small size of the bore holes, the tunnels breaking through the wood surface and their occurrence in damp timber directly connected to walls we can assume that the damage is caused by wood-boring weevils (*euophyrum confine*).

Wood-boring weevils can be removed by removing the damp conditions, but as these smaller holes and tunnels seem equally deserted, no remedial action must be taken. It should be tested though, if the timber is still sufficiently load-bearing.

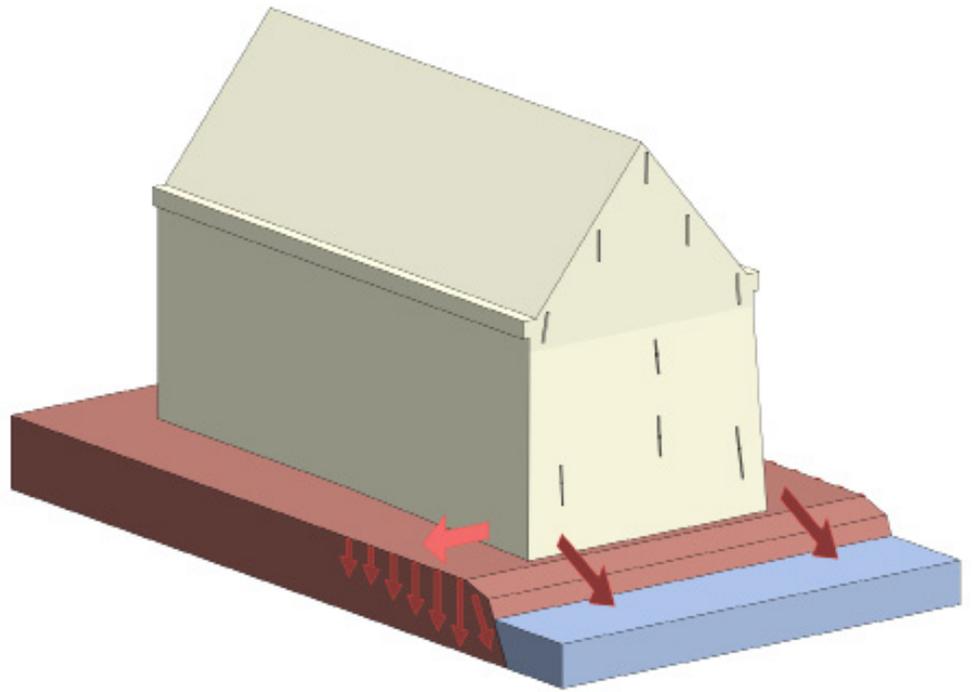
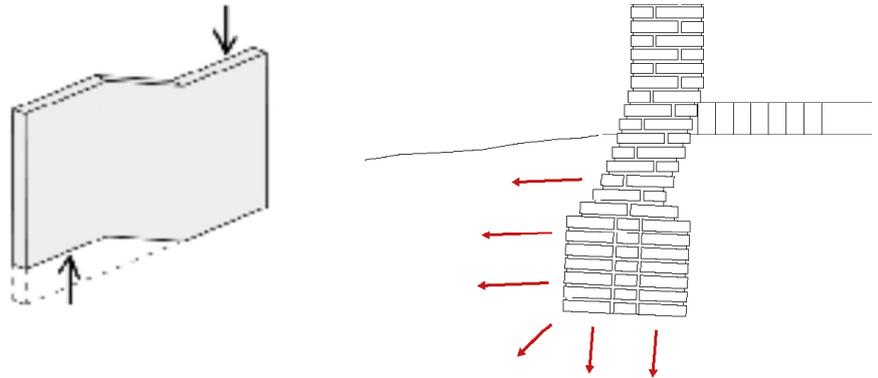
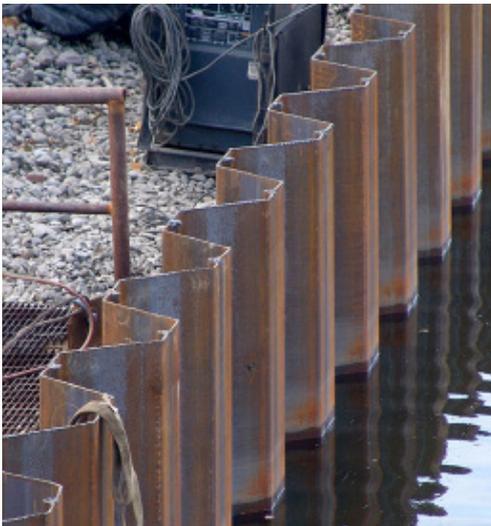
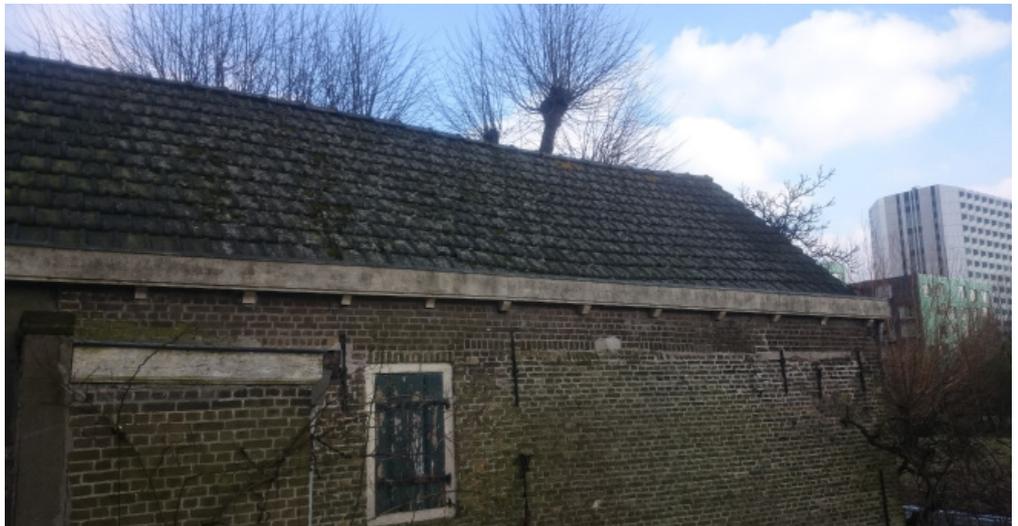
05.2 Displacement

Diagnosis:
brick > deformation >
displacement
Settlement

Hypothesis: Due to the different directions of wall base deformation caused by settlement, walls are being pulled apart from each other. This is the most severe damage observed in the building, because it directly threatens the integrity of the structure. The vertical crack goes through and through the wall, in fact south and west facades are separated and do not perform as one structure anymore.

Intervention Proposal:

Integrity of the structure must be preserved if building has to be reused in any way. Proposal to achieve that is to place the flexible bars in the bedding mortar of the masonry wall. Bars will carry the tensile force occurring because of movement of two walls in different directions. This way corner of the building will be held together.

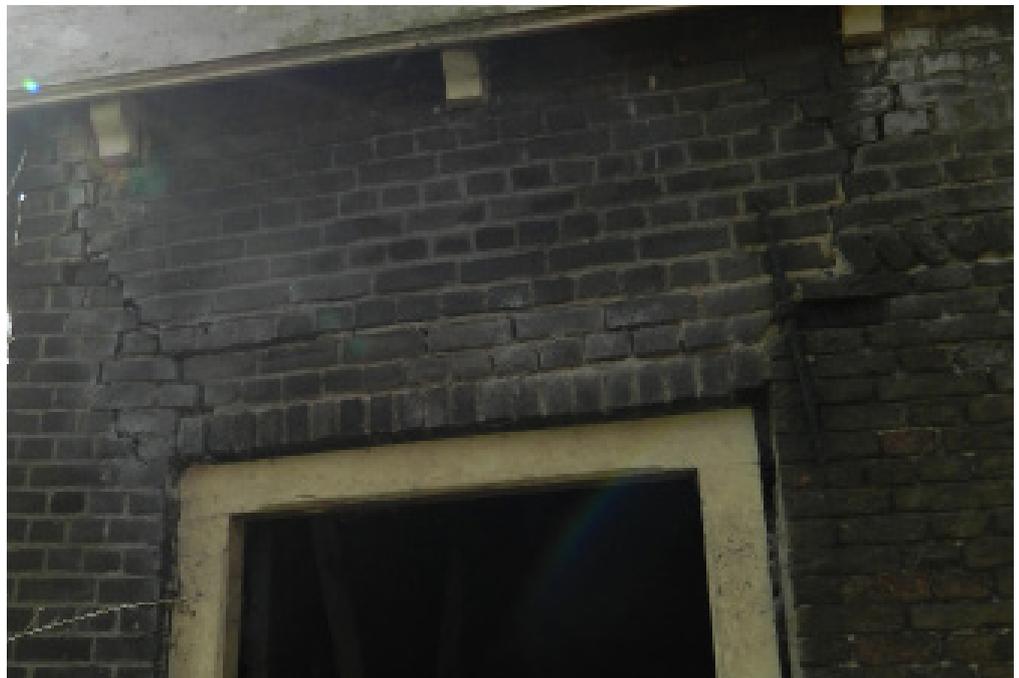
05.3 Cracks above the door

Structural damage > Cracking
> Cracking in column or wall
> Combination of cracks in different directions

As stated in the first point, most of the damaging processes are related to settlement. First the ground must be stabilized, before further repairs would make any sense - if the settlement proceeds, the cracks will most probably re-open even if they would be sealed in the early stage of intervention.

For safety reasons temporary support for the door can be provided to keep the damaged opening from collapsing.

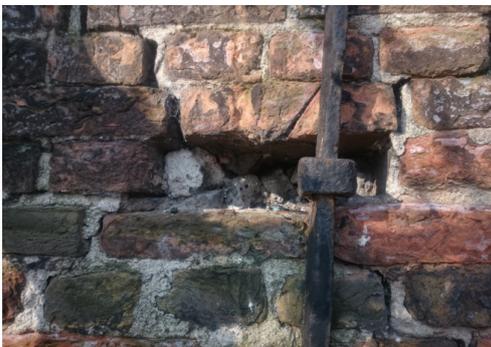
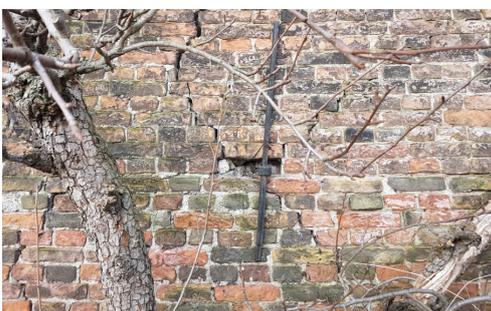
05.4 Cracks around the anchors

brick > cracking > star crack

The structure of the mill inside the barn is connected to the wall with iron anchors. These anchors, attached to the internal structure counter-act the movement of the wall to the front (caused both by settlement and deformation due to overload). Result of this reaction focused in the points of anchors is the concentrated force causing the star shaped cracks around the anchors.

Since the anchors connect the structure of the mill to the wall it is possible that dynamic forces damaged the wall prior to formation of cracks- the wall was already weakened in the points of anchors. Mill is not active for a long time though, therefore this thread is not active anymore.

Cracks can be sealed, but again as in the previous damage mechanism, it is a priority to remedy the settlement. Without stopping the movement of the wall, the repair of the cracks will probably not be effective, they will sooner or later re-open.

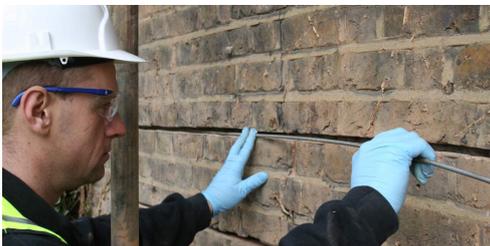
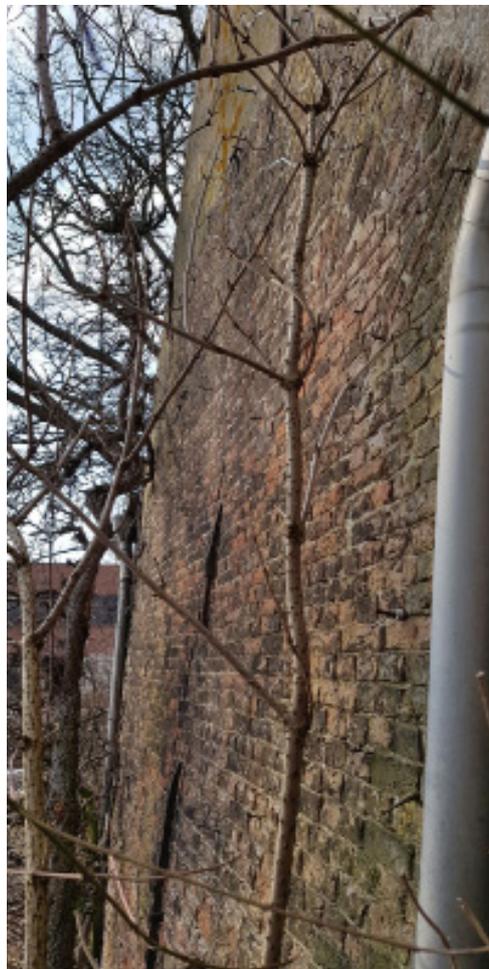
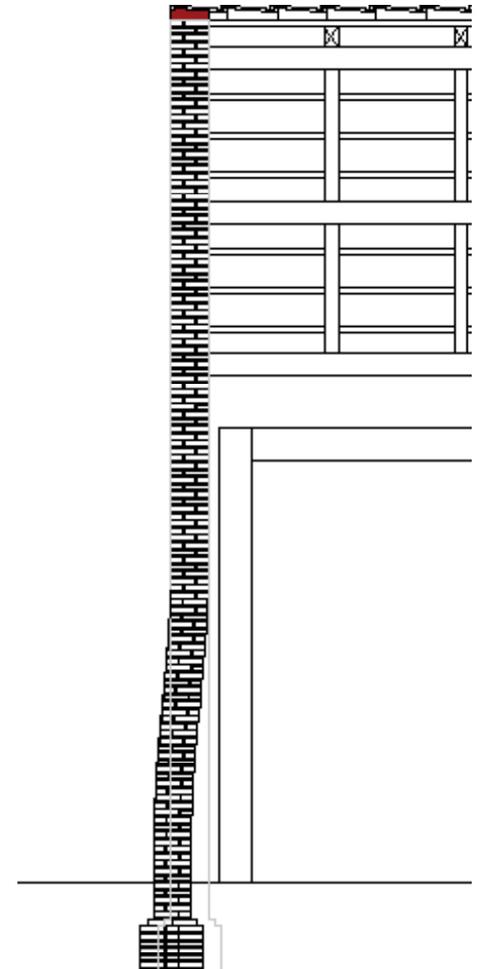
05.5 Damage due to increased roof load

Diagnosis: structural damage
>> deformation >> Deformation pattern 55

Hypothesis: During the recent reconstruction of the roof additional brick layers have been added to the wall and the reed roof has been replaced by roof tiles. By that the load resting on the existing walls increased. This development results in deformation pattern 55, which is facilitated by the settlement displacing the wall from its perpendicular orientation and making it more vulnerable.

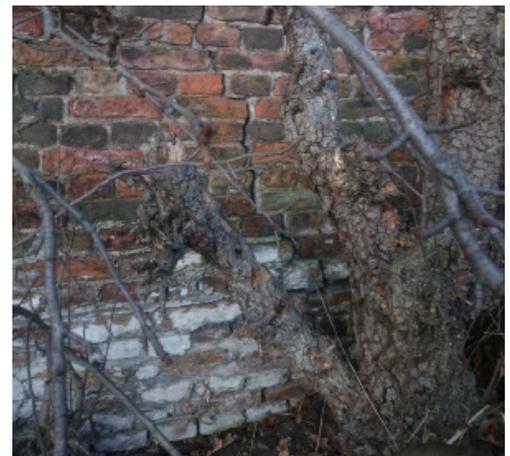
05.6 Biological growth

Diagnosis: brick >> biological growth >> higher plants

Hypothesis: A tree - adjacent to the wall - is growing from the centre the South façade. Due to its expanding roots eccentric forces push soil and masonry away and parts of the roots appear to even grow through cracks in the masonry. Big parts of the foundation and parts of the wall are displaced. Notwithstanding a supportive structural function can be accredited to the tree as it is holding back the bulging and settling of the wall.

As long as the future use of the barn remains unclear, an intervention proposal cannot be given. Clearly the tree and the wall are strongly connected and only a proper use can justify the removal of the tree (poisoning, reinforcement foundation) whereas leaving the tree be (even though the changes between 2012 and 2018 are minute and the tree seems to grow very slow) will sooner or later result in further displacement of parts of the wall and foundation.
